# B1 NEWS

Newsletter of the Thompson B1 Locomotive Trust

NUMBER 85

SEPTEMBER 2017

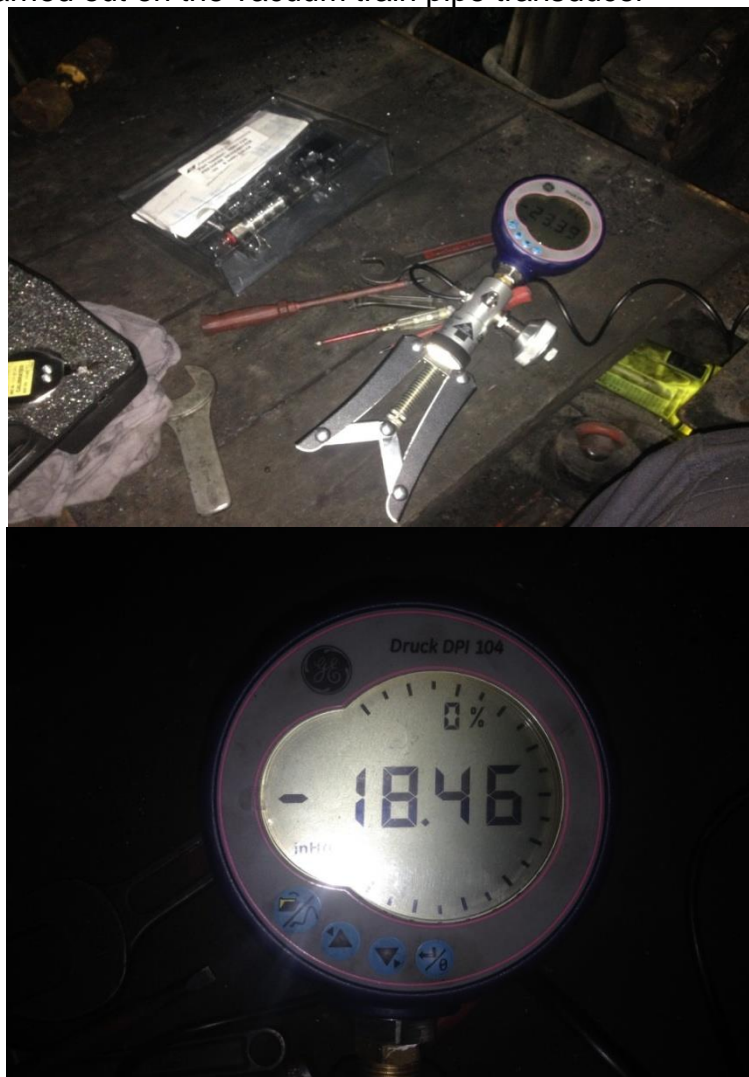
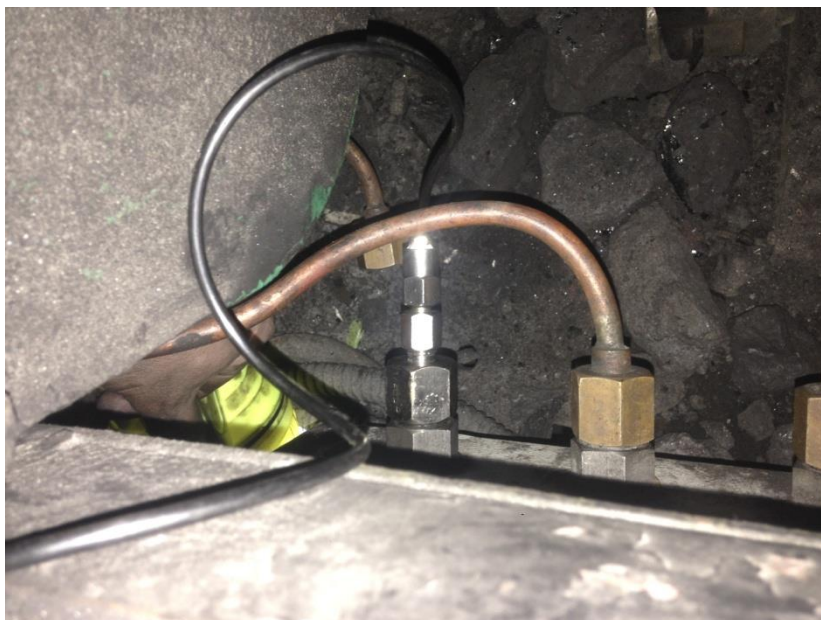
With a replacement code plug fitted in the code plug socket and armed with the instructions and following the prompts given by the software, the default configuration file was extracted from the OTMR and the relevant information programmed into the code plug. This done, the configuration file was opened up so that all the channels were in a format that could easily be modified to make it specific to 61264. However, what at first looked relatively simple turned out not to be and further advice was sought from Arrowvale, this time over the phone. The end result being that the read out for the steam brake which had previously been in BARs and named airbrake pressure was configured to read in PSI and renamed MK4 Steam Brake Pressure. The channels that were not relevant to the loco were turned off thus saving valuable space in the 2MB internal memory in the OTMR. Eager to see if the changes were successful I carried out a hand pump test of each individual transducer. This involved disconnecting the pipe work from each of the transducers and attaching a small hand pump fitted with a digital pressure gauge and applying either pressure or vacuum with the OTMR switched so that it records the output from the transducer. The pictures below show the hand pump test being carried out on the vacuum train pipe transducer

The hand pump test proved that all of the pressure transducers were working correctly and that the vacuum transducer was giving a spurious output. The suspect transducer was swapped for a brand new one from our stock and the hand pump test carried out again. Unfortunately, this wasn't a total success as the transducer with no vacuum applied was giving an output equal to thirty inches of vacuum on the download instead of showing zero with vacuum applied it was giving an output that was falling towards zero instead of rising from it. Before delving deeper into the fault with vacuum output I decided to contact Arrowvale Electronics who supplied the unit and GE sensing who manufacture them for advice which proved to be inconclusive as one suggested contacting the other and vice versa.

At this point, with advice from Dave Fowler via email from South Africa I decided to tackle the problem myself by following a logical sequence of fault finding. This involved carrying out a continuity test of the associated wiring and then setting up a multimeter as part of the circuit to measure the output in milliamps. During the continuity test, wiring that was found to be satisfactory was indicated by a buzzer sounding on the multimeter. The next step involved connecting the multimeter as part of the circuit to read the output from the transducer, which at zero should be 4 milliamps. However, the test showed that the output was 20milliamps, which is the maximum output for that type of transducer with no vacuum applied to it. Completely disconnecting the transducer and removing it from the box under the cab floor highlighted the problem. The type of transducer fitted was in fact a -30" HG to 0" HG transducer hence at what is normally zero inches of vacuum on the gauge it would read maximum output and fall towards zero with the increase in vacuum.

The issue was solved by fitting a transducer which I had left over from assisting with fitting out of sister B1 61306 Mayflower with its OTMR system. This was of the correct type reading from 0" HG to 30" HG which gives a reading of 0"HG with no vacuum applied rising to 30"HG at full output with vacuum applied to the transducer. This effectively mimics the reading shown on the locomotives vacuum gauge. To prove the system and make sure I was right in what I had done a hand pump test was carried out with a multimeter included in the loop to measure the output. This started at 4ma and rose to 20ma at full deflection; the download also proved the system to be operating correctly. As can be seen from the download the system worked as it should

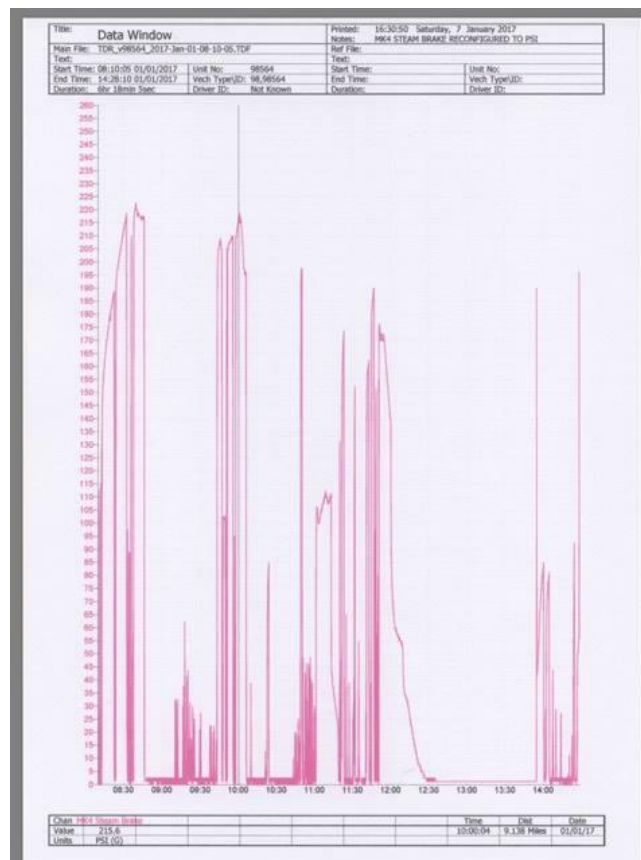
The graph below shows a print out from the OTMR for the steam brake pressure transducer with pressure being displayed on the left axis and time of day on the bottom axis

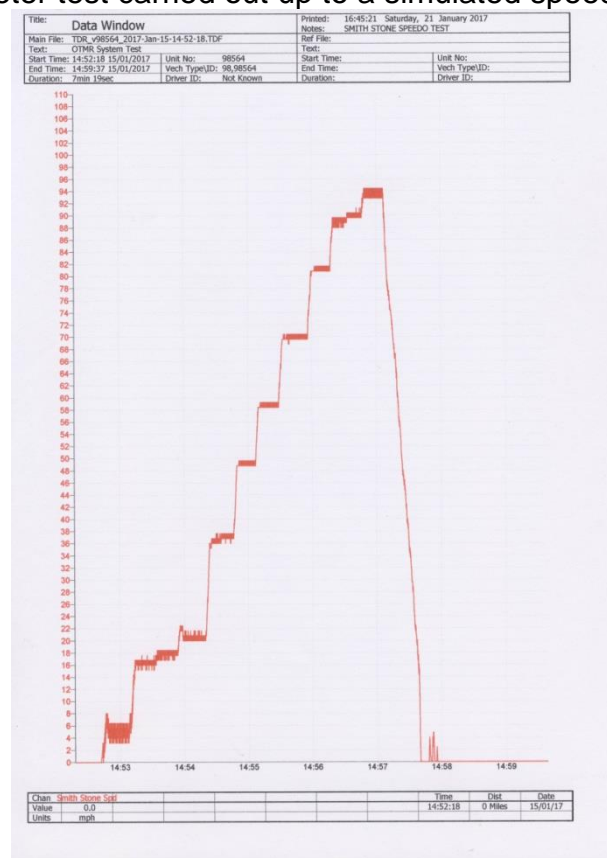
The graph below shows the corrected speedometer output generated during the speedometer test carried out up to a simulated speed of 95MPH

A further issue that became apparent is the speedometer giving a reading that is roughly 50% of the true road speed. Having got hold of a copy of the handbook for Smith Stone speedometer equipment, it became clear that the system fitted to the locomotive operated using a 4-volt system and 4-inch speedometer with an axlebox mounted generator driven by a drive arm to produce the output rather than the standard 8-volt system and 6-inch diameter speedometer with crank mounted generator fitted to many locomotives by British Railways. Both systems have a maximum output of 40 volts at either 4 or 8 volts per 100RPM. The 8-volt system reaches its maximum output of 40 volts at 500RPM the 4-volt system reaches its maximum output at 1000RPM, exactly 100% faster than the 8-volt system. After several hours of head scratching and calculations the issue was eventually attributed to an unforeseen error dating to back to when the OTMR set was fitted to the locomotive. When it had been programmed it had been configured to take an input from a crank mounted 8-volt Smiths Stone Speedometer with gain and offset figures to suit such a system. The solution to this issue became clear when the settings for the speedometer channel were accessed in the analyser software. The reading given on the OTMR is adjusted by using two figures, an offset figure and a gain figure. The offset figure was zero so the adjustment of the output would have to be done using the gain figure. Referring back to the download I realised that the actual inaccuracy of the output was 100% of the readings being given on the download; for example, at 30mph the output read 15mph, exactly 100% difference using this theory. The gain figure was increased by 100% from 0.4 to 0.8 and the settings saved. To prove the changes a speedometer test was carried out up to 95mph and the results downloaded. Although the reading on the download was unstable due to the method used to drive the generator, it clearly showed that the adjustment had had the desired effect, with the output and speedometer reading the same.

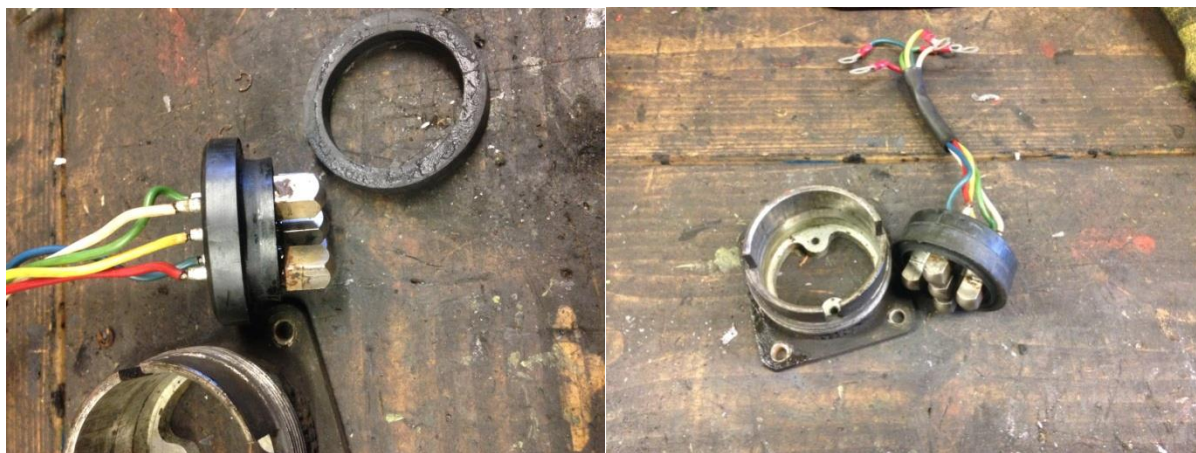
The second fault was found at the front of the loco in the ATC junction box which is mounted behind the front screw coupling. On the side of the junction box is a socket with 5 pins all of which are sprung upon disconnecting the AWS receiver harness from the junction box. We found that 2 out of 5 pins were seized in the holes and holding the other 3 off the corresponding terminals in the plug causing a bad connection between the receiver and the junction box. The wiring to the socket was disconnected and the socket unbolted from the side of the junction box and a replacement socket fitted. The offending item is shown in the pictures below.

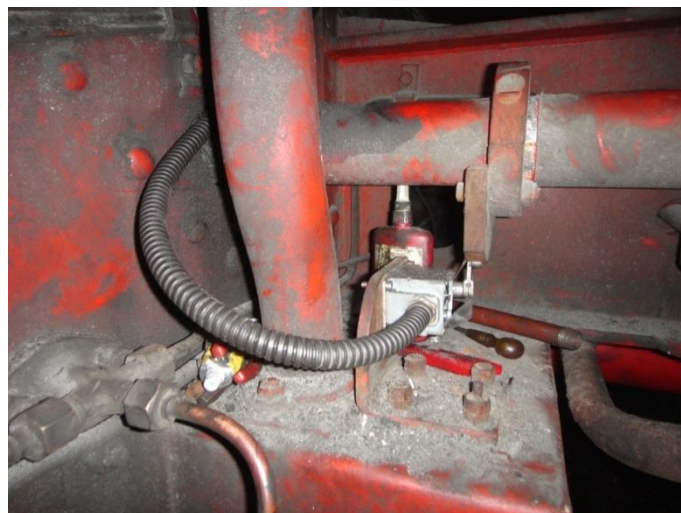
The finished job with the new switch and section of flexible conduit in place

I came back in on the Wednesday and attacked the problem again, firstly configuring the new switch so it didn't latch in position and fitting it to the bracket below the reverser. The the second job was fitting a new flexible conduit of the correct length to keep it away from the steam pipe and finally shortening and recrimping all of the wiring before wiring up the switch. Having wired up the switch and tested the aerial switching unit which now defaulted to the front TPWS aerial in mid gear and switched to the back TPWS aerial in around 15% back gear a full functional test of both the AWS system and TPWS system was carried out. This was completed successfully and touch wood puts an end to the issues we were having with both systems.
