# B1 NEWS

**Newsletter of the Thompson B1 Locomotive Trust**

NUMBER 89

JUNE 2019

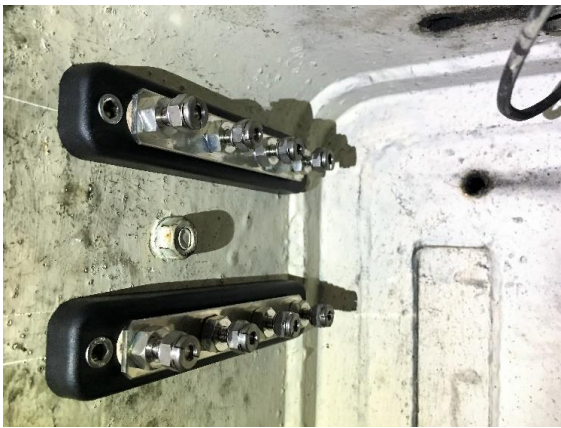
*The photo opposite shows the two busbars mounted in the top of the loco's battery box. One is for positive connections, the other for negative connections. The metal parts are all stainless steel as are the nuts and cap screws holding everything in place.*

As part of the planned work the decision was taken to improve the battery box wiring which over time had suffered somewhat and needed replacement and improvement of the somewhat confusing layout. This consisted of multiple wires all the same colour and a number of different wires connected directly to the batteries. As with all these things hindsight is a wonderful thing and it is very easy to pick fault and say, "I wouldn't have done it like that". To resolve the problem the existing wiring was separated into positive and negative connections and then shorted, and the terminals crimped to two heavy duty marine type busbars. These were then mounted in the top of the battery box, one for the positive wires and one for the negative wires. This has removed the need for multiple wires being directly attached to the battery terminals. To further improve the situation a set of 50-amp battery connection cables have been installed so that the wiring connecting the two batteries is now much more robust and will reduce the voltage drop between the two batteries. These also connect the batteries to the positive and negative busbars via an Anderson Battery connector which is used to connect the other half of the battery box wiring positive and negative cables attached to the busbars. The use of such a connection also makes removal of the batteries a much easier process, without causing damage to the wiring. The work involved took around half a day to complete and the hardest part about it was actually starting the job. As they say a picture can paint a thousand words and photos below will make the description of the work much clearer.

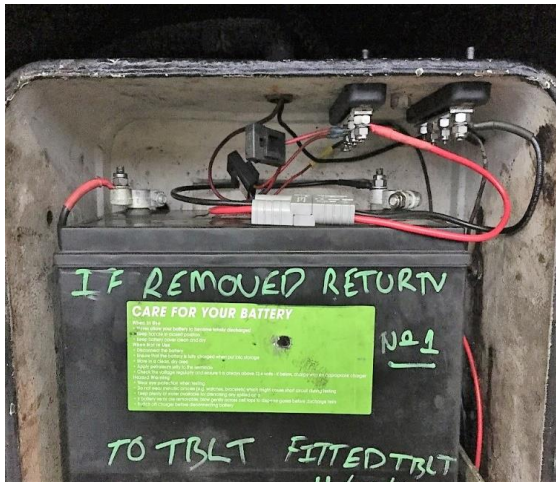
*As can be seen in this image the new layout is much more logical and robust. It includes an Anderson battery connector which is the grey object sat on top of the battery*

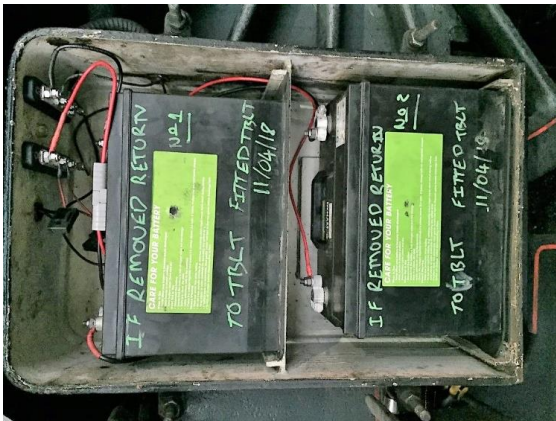
*This photo shows the full layout of the battery box with both batteries connected and all cables routed appropriately. Hopefully this provides a much-improved layout with more robust wiring and connections compared with the original design.*

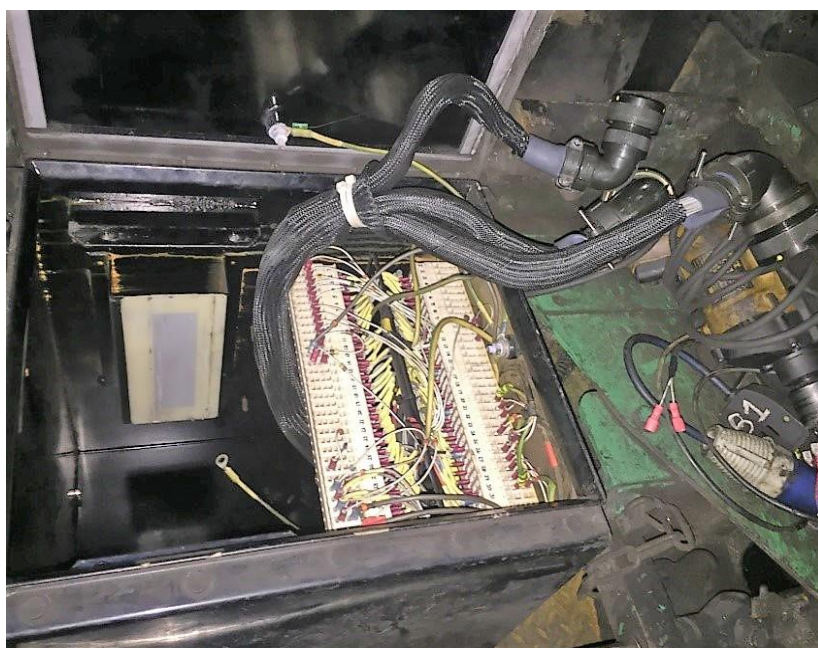
*The photo left shows the OTMR wiring loom part way through removal to allow access to the location of the two status LEDs. Removal of this was the cause of a great deal of annoyance and distress*

Unbeknown to me the two OMTR status LEDs had also failed. These indicate if the OTMR is functioning correctly as indicated by a blue LED, or if it has developed a fault, as indicated by a red LED. New LEDs were therefore ordered from RS Components and arrived the next day and the work planned in to get them replaced.

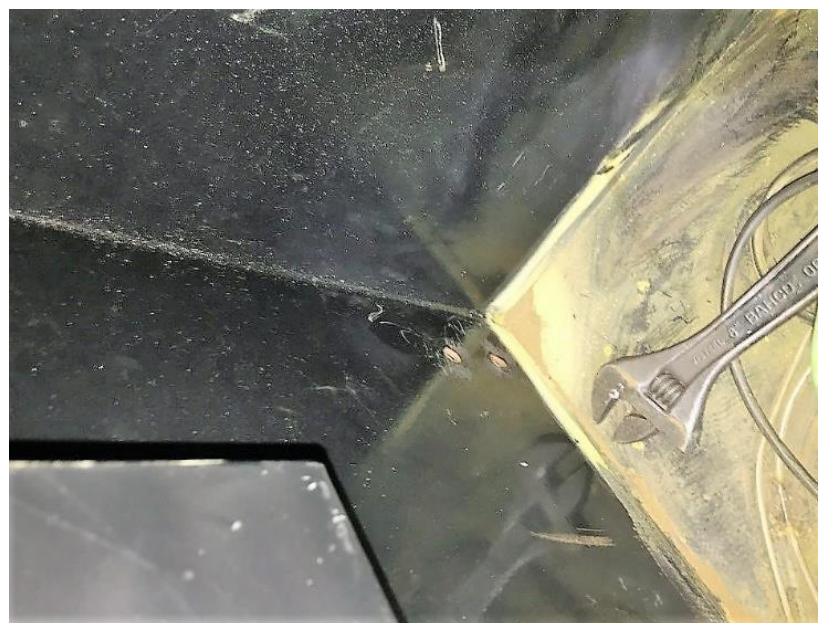
*This image shows the location of the two LEDs within the OTMR enclosure. To gain access to this point the OTMR wiring loom had to be removed. When originally fitted the loom and OTMR obviously hadn't been fitted to allow easy access to the front of the enclosure. With everything inside it is impossible to see the front of the box let alone reach it.*

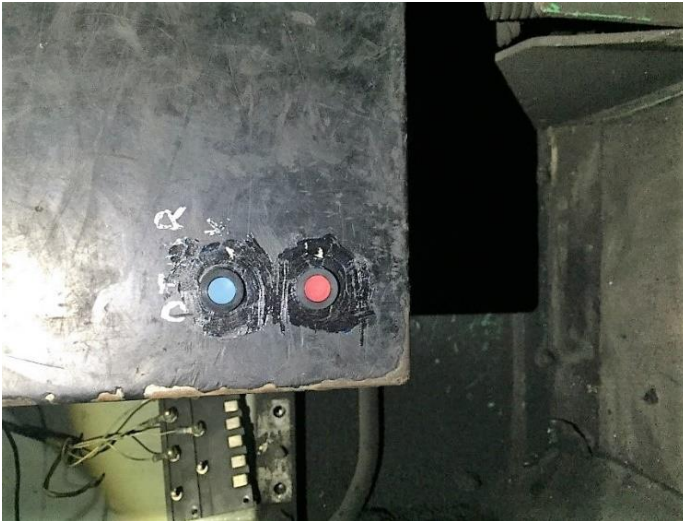
*The picture to the left shows both LEDs, one blue and one red, fitted into position and connected up. The shiny substance around the LEDs is a silicone gasket compound to help prevent the ingress of water via the holes.*

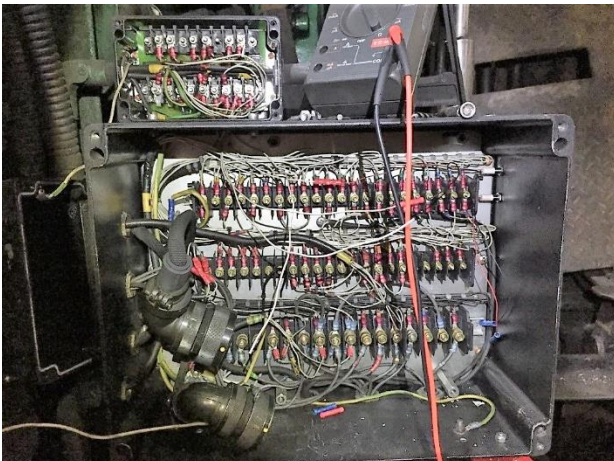
*The photo left shows the wiring located behind the TPWS/AWS control unit and mounted above it the TPWS aerial switching unit. To connect the LEDs the relevant wires and terminals had to be traced and made so that the LEDs would swap over dependent on forward or backward gear.*

At some point last year there had been considerable confusion regarding the operation of the TPWS aerial changeover switch which is mounted below the reverser weigh shaft between the frame of the locomotive. This forms part of the circuit that selects either the front or back TPWS aerial and several heated phone calls ensued about the issue. There are two TPWS aerials which pick up different radio frequencies from lineside equipment mounted between the rails. One on the loco under the front bogie and one on the tender on the rearmost frame stretcher. Only one of these must be selected, depending on the direction of travel, i.e. front for forward and back for reverse, running tender first. The switch contacts are operated by a cam on the reverser weigh shaft and configured in such a way that they operate the TPWS aerial switching unit mounted above the TPWS control unit in the cab. To avoid such confusion in the future two white LED indicators have been fitted into the side of the control unit enclosure and these will illuminate or extinguish according to the aerial selected. As per the original steam locomotive TPWS/AWS wiring diagram such LEDs are not a requirement and subsequently most steam locomotives were not fitted with them. However, over time problems develop with such a system, as do the solutions to resolve them, and in this case a number of locomotives were retrospectively fitted with LEDs to prove operation of the changeover switch. In the back of my mind I have a recollection of a representative of the then vehicle acceptance body recommending that they be fitted. Again, it took a day to complete the simple task of drilling two holes, tracing wires and making connections in the TPWS aerial switching unit and performing a test to ensure that the LEDs swapped according to the reverser being in forward or backward gear. The pictures below show the LEDs in position.

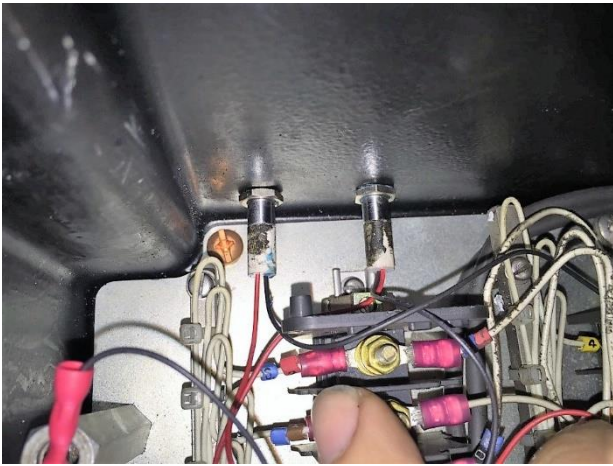
*As can be seen the LED indicators just fitted within the space available and were positioned so that they didn't interfere with any other wiring within the control unit enclosure.*

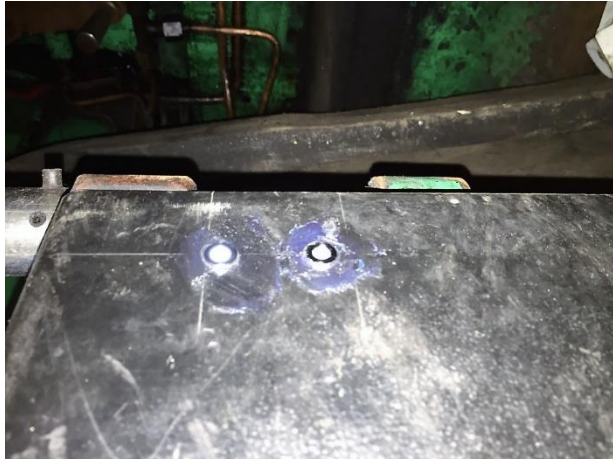
*This image shows the view from outside the enclosure. The top LED is for Forwards, the bottom LED is for Backwards. These will be labelled accordingly and will highlight if the changeover switch has failed.*

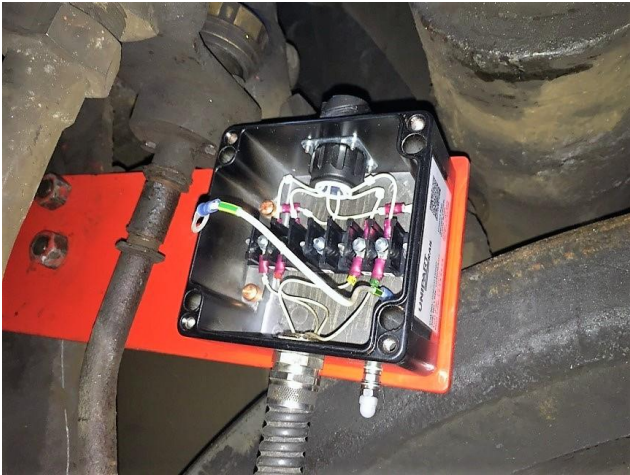
*As can be seen from this photo the aerial box is now mounted in a much better position and although not overly apparent it is mounted at a 30-degree angle. What it does show is the greatly improved access to the electrical connection within the box which can now be worked on without fear of losing anything.*

As part of the work we committed to WCRC to undertake, two new TPWS aerial junction boxes were ordered. One to replace the one mounted on the tender, on which the bayonet connection appeared to be heavily corroded and therefore suspect, and one to be held as a spare. Again, what seemed a simple thing to do developed into a more complicated process as it was decided that the original location of the junction box was unsuitable due to it being mounted horizontally on the dragbox. This caused two issues, the first being that the 90-degree angle at which the jumper cable connection sat put undue strain on the bayonet connector and the weight of the cable was trying to shear it off. Secondly to carry out any work on the contents of the box entailed lying flat on your back and working overhead with the attendant risk of dropping and losing nuts and washers. A more suitable location for the box was found and a mounting bracket manufactured to allow the box to be mounted vertically and at a 30-degree angle with the connection pointing downwards. This reduces the strain on the bayonet connector because it is now under tension, which that type in particular, will withstand. Mounting the box vertically also removes the need to lay on your back to work on it, making connecting up the wiring much easier. Another benefit is that with the box being at a 30-degree angle any water or coal dust is more inclined to run off, rather than collect on top of it.

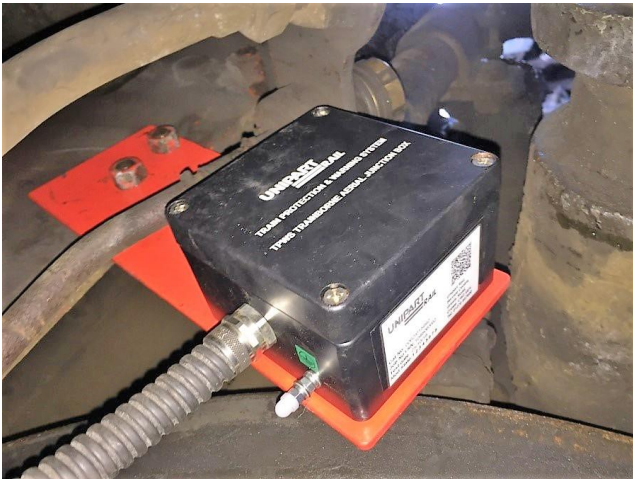
*The complete assembly with the cover fitted. The 30-degree angle is more apparent. Hopefully this will solve the issue of straining the bayonet connection on the engine to tender jumper cable as both junction boxes now slope at the same angle.*

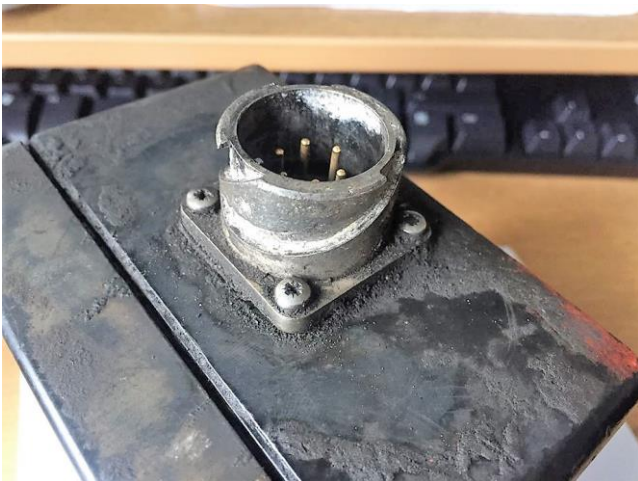
*This photo shows how the bayonet connector has suffered from the effects of corrosion caused by moisture ingress over the years it has been fitted. Although not particularly heavy it was a cause of concern.*

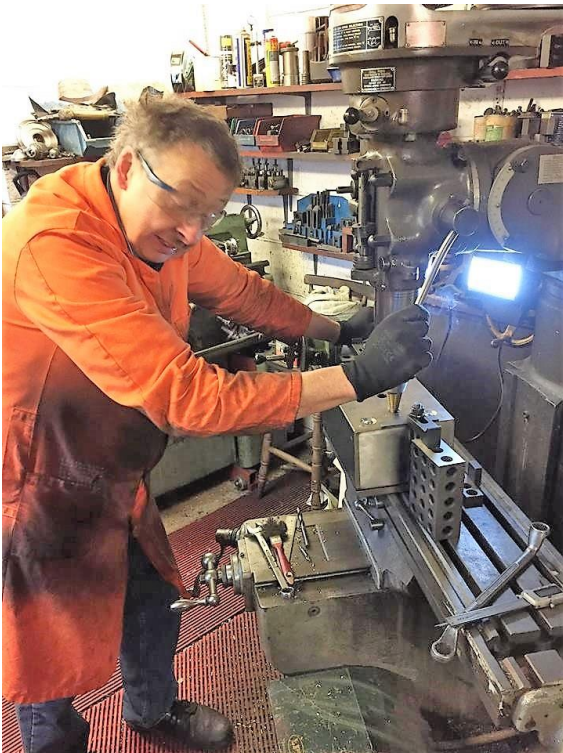
*Steve Andrews is seen carefully drilling the holes for mounting the transducers in the box. This was done on his milling machine with the box securely clamped to the table of the machine. This allowed the holes to be drilled with considerable accuracy in comparison to using a pillar drill*

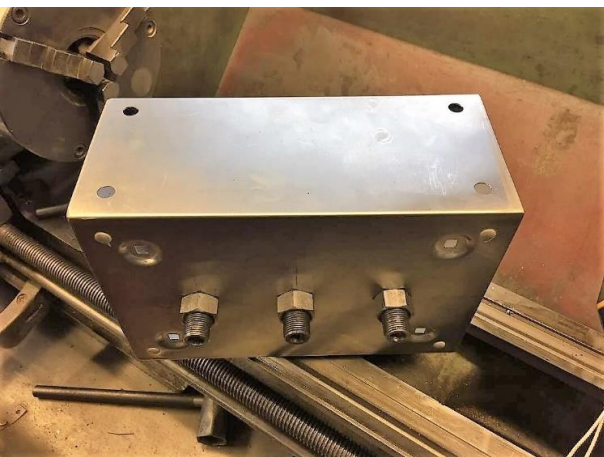
*Externally the finished box with all the relevant mounting holes drilled and sharp edges removed. The work was undertaken in Steve Andrews' workshop because everything was conveniently on hand and an inordinate time was not spent searching for the right tools*

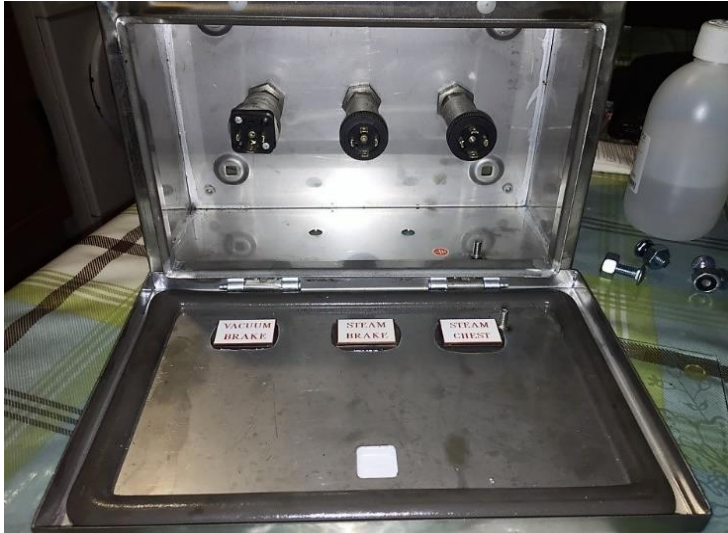
*The inside of the enclosure prior to fitting a set of twin terminals and links to facilitate easy disconnection of the six electrical connections that relate to the transducers. At this point plastic labels were being fitted in order of the transducers and their applications.*

*(L to R) vacuum brake, steam brake, and steam chest pressure. These produce an output which is recorded by the OTMR*

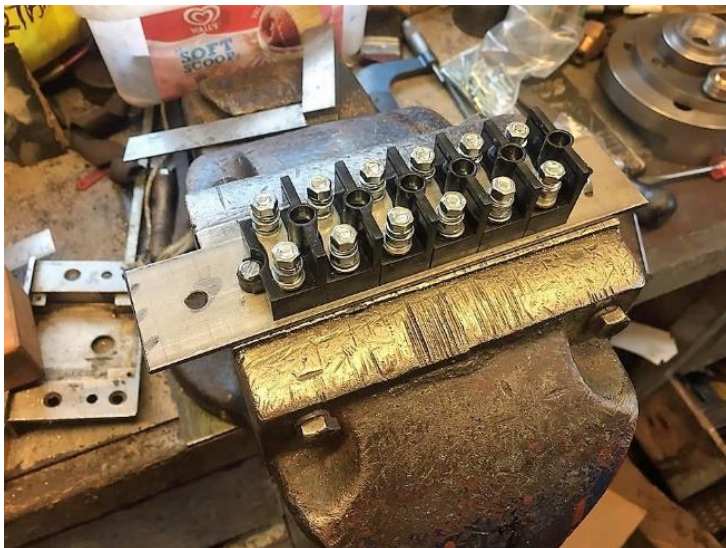
*As delivered the busbar comes as separate segments to allow the number of terminals and links to be configured for a given application. These are then slotted into place and bolted down into position.*

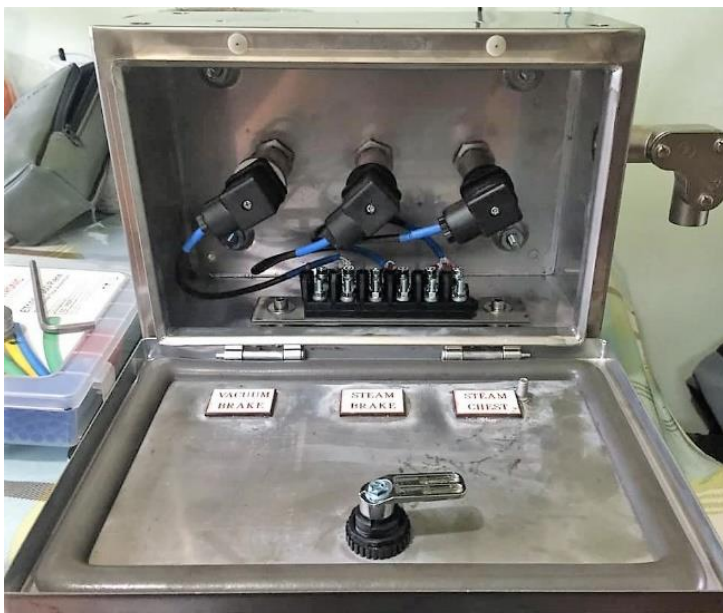
*The finished transducer enclosure complete with internal wiring and stainless steel conduit inspection elbow*

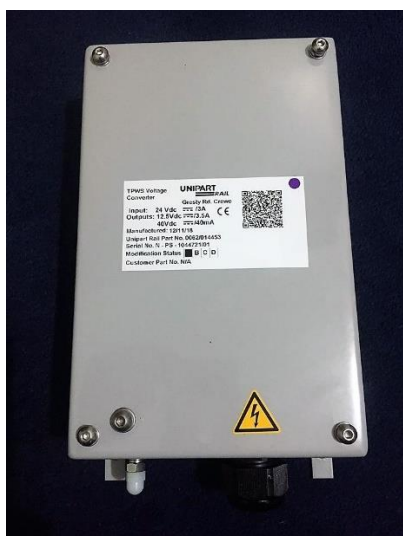
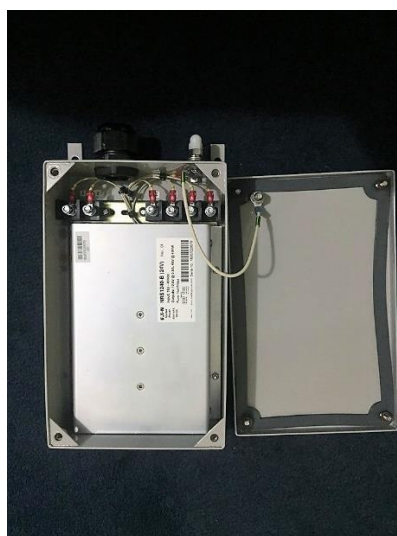
*These photos show the new style of voltage converter which is considerably smaller in size than the previous DMU type that was initially fitted to 1264 when the AWS system was installed, shortly after it entered traffic in the late 1990s. As with many things the use of electronics has reduced its size.*

Several ideas were bounced around regarding where best to fit the new voltage converter as it is much smaller, meaning that the footprint compared to the old one has been greatly reduced. However, to protect the investment made in the new unit it has been mounted inside a rail industry spec electrical enclosure manufactured by the same company that supply Unipart Rail. Although this hasn't greatly reduced the footprint of the system, it has, by judicious use of panel mounted switches, consolidated the two isolation switches into one location within the enclosure. The enclosure itself is mounted on the fireman's side with all the switches and the voltage converter mounted inside it. In the pictures below the voltage converter is shown prior to fitting within the enclosure.

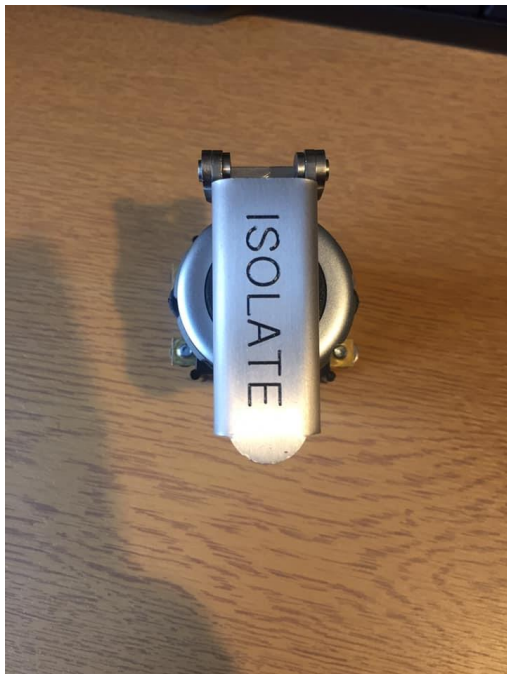
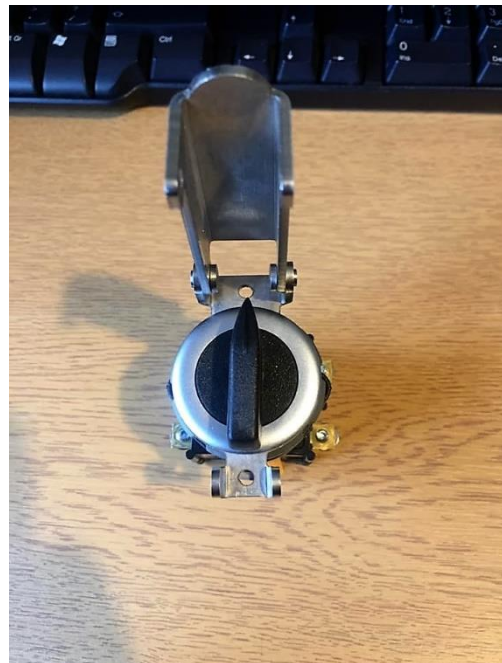
*These images show the TPWS / AWS independent isolation switch and its protective latch to prevent deliberate or inadvertent operation. This whole assembly meets with the rail industry's standard for low voltage switch gear and is manufactured in the West Midlands*

As part of this upgrade a separate isolation switch has been installed to independently isolate the TPWS and AWS without isolating the OTMR, meaning that the isolation is recorded and that the other outputs can be monitored. This has been done on the recommendation of WCRC and follows a similar set up fitted to their locos. The switch has to be protected in some way, in this case by a latch and break seal arrangement, which was supplied by the manufacturer of the switch, rather than by adapting a standard isolation switch. The design and completed assembly are compliant with rail industry standards and readily available. According to the requirements drawn up by the Office of Road and Rail in response to the *Tangmere* incident at Wootton Bassett, the primary isolation switch needs to be lockable in the 'on' position, to avoid it being deliberately or inadvertently isolated. To avoid modifying an 'off the shelf' switch, discussions with the same switch manufacturer resulted in a solution being found. Again, this is an 'off the shelf' unit they supply, in a configuration that can be secured by a padlock in the 'on' position, something that seemed to cause confusion with other switch gear manufacturers. As mentioned previously, whilst not the cheapest option, use of these switches has allowed them to be consolidated into one location and has made the system compliant once again. The addition of a DC voltmeter will also allow the battery supply voltage to be monitored, which will go some way to avoiding a repeat of a battery failure in future and will remain live when the safety systems are isolated.

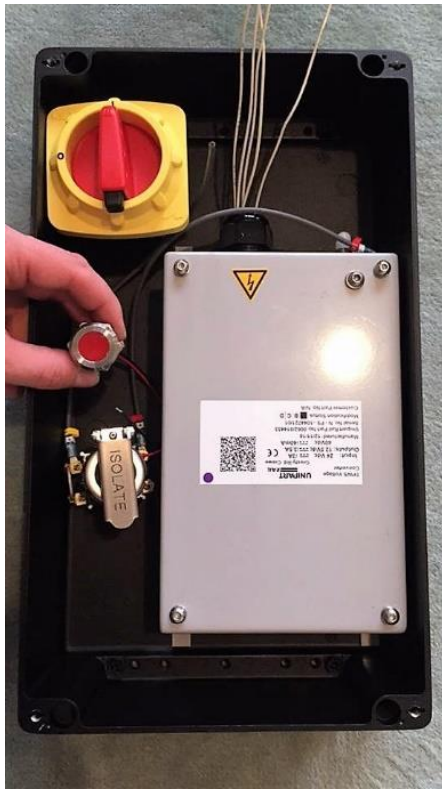
The photo on the left shows the rough layout of the various items that make up the enclosure. Whilst the design had been drawn up half scale, only by trying out different arrangements could the best use of space in the enclosure be worked out. The chosen layout also had to allow for wiring to be routed to avoid pinch points and unnecessary strain on the electrical connections.

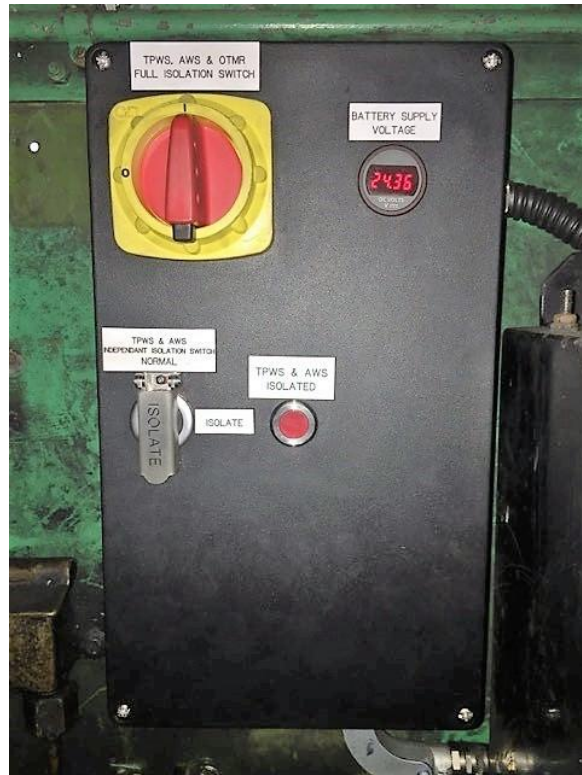
The photo on the right shows the enclosure mounted in position with all switches and indicators labelled up. As can be seen the new layout is much neater and allows the isolation of the TPWS & AWS in the event of a failure. The voltmeter has been included so that the battery voltage can be monitored throughout a mainline trip.

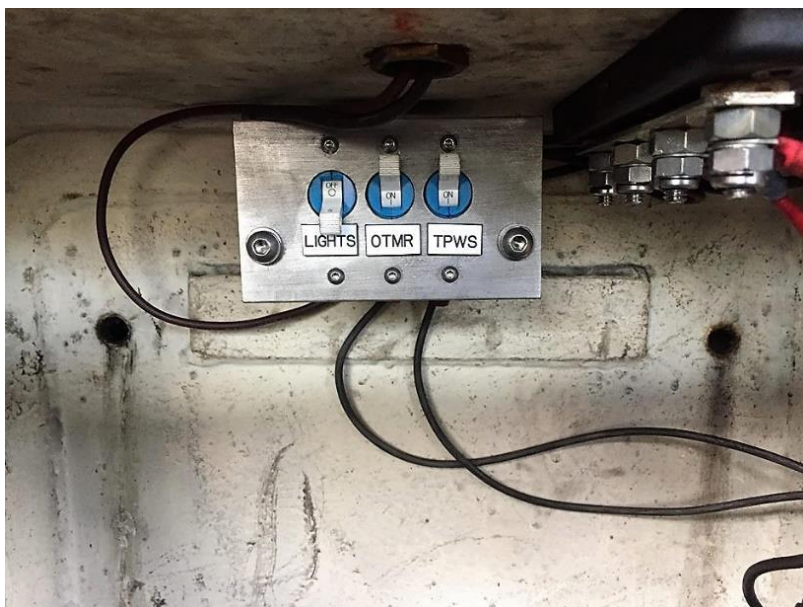
As a further improvement to the electrical system, proper electrical protection has been installed in place of the previous automobile style blade fuses, which were unsuitable. The new system is now protected by three 5 Amp miniature circuit breakers. These are shown above mounted in position within the battery box.

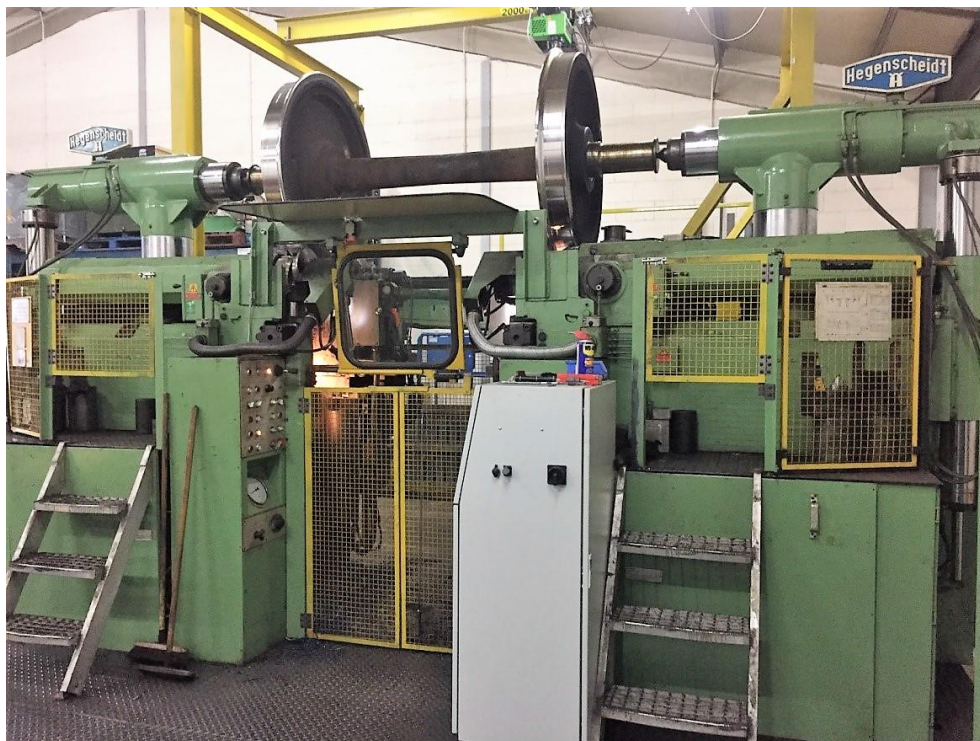
A further very noticeable issue was that over the years the tyre treads had worn hollow resulting in a substantial discrepancy in diameter between wheels. When new the difference allowed between wheels on one axle is 0.25mm, but in one case this was close to 3mm, due to the hollow wear. The tyres have now been turned to recover the profile and flanges to within the acceptable limits. However, this has left them roughly 1.5mm above last turning tyre thickness of 41mm, meaning that at the next overhaul new tyres will have to be fitted.

*This photo shows one of the tender wheelsets during reprofiling on the wheel lathe at RMTS, who are the UK agents for the German wheel lathe manufacturer Hegenscheidt MFD. This is now very much the machine of choice for train operating companies and this one was removed as scrap from Northern Rail's Longsight Depot in Manchester.*

As part of the planned winter maintenance work the tender axlebox bearing crowns have had the white metal built up to remove excessive side play. As part of this process the tender wheelsets were removed and sent to Richardson Machine Tools Services (RMTS) at Staveley, near Chesterfield for reprofiling due to all wheelsets having thin flanges or being very close to being outside the acceptable limits of wear.

To give you some idea of how much material has been removed, the tyres when new, (which granted was some time ago), start off life 75mm thick and to recover 1mm of lost flange thickness requires the removal of 4mm of tyre thickness. This confirms the old rule of thumb that you only get three goes on a wheel lathe before an engine needs new tyres.

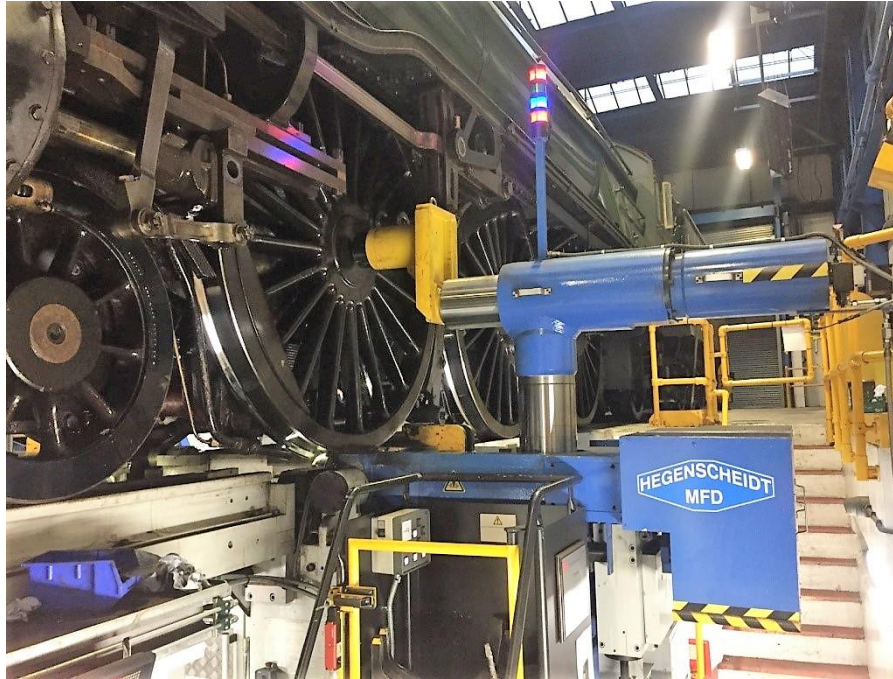
*The photo above shows a lathe mounted below floor level as is the normal convention enabling locos and wagons to be shunted over the top of it without having to have their wheels removed  
Both photos courtesy of Steve Robb*
