B1 NEWS *flash*

Newsflash of the Thompson B1 Locomotive Trust

April 2017

Superheater problems for 61264

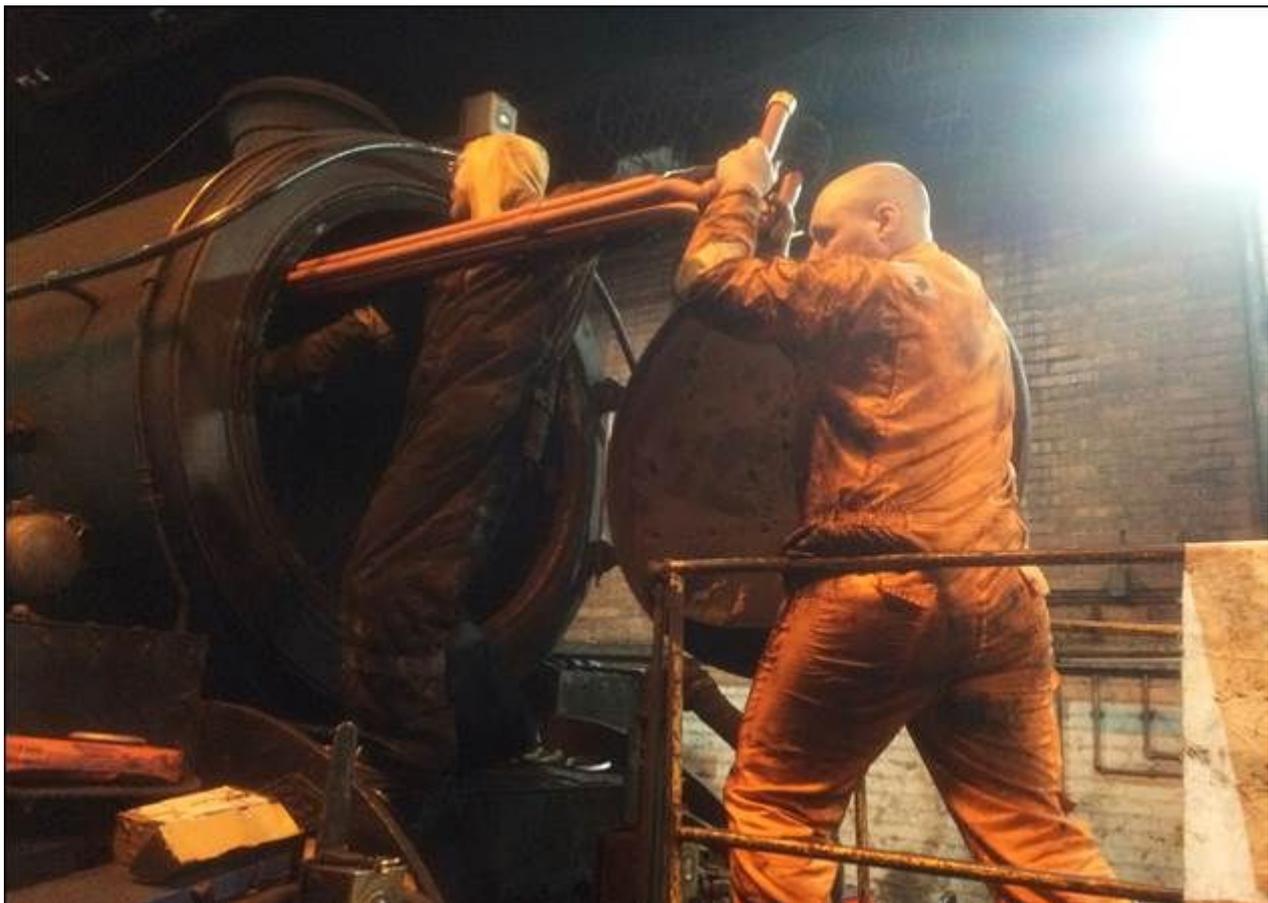
Not the image we would really like to see at the beginning of the season as Dave and Tom from the shed staff at the North Yorkshire Moors Railway insert a superheater element through the smokebox door. Photo courtesy of Dave Fowler.

After a very successful week at the KWVR Steam Gala, followed by the Whitby Flyer railtour, we were disappointed to find on returning to Grosmont that steam and water was leaking from somewhere on the superheater header. Our boilermaker, Mark O'Brien, inspected the header and found it was coming from one of the superheater elements. When the locomotive had cooled down, Mark removed the suspect element and found a small pinhole in the wall, which had worn very thin.

On reporting this to Steve Andrews it was decided to renew all the elements without delay. The elements take at least 10 weeks to be produced, but Mark knew that the owner of B1 'Mayflower' no 61306 had just had some made and were in store at Adam Dalglish's workshop waiting to be fitted once its boiler repairs were complete. After phone calls to David Buck (owner of 61306) he generously agreed we could have them as long as we replaced them within ten weeks. Mark immediately placed an order for the 24 elements with Thorne International at a cost of £15,200.

The MPD at NYMR agreed to fit the elements and Paul Middleton fetched them the same day and the boiler fitters Chris, Tom and Dave stripped out the old and started fitting the new ones. Unfortunately the main steam pipes had to come off to allow the elements to go out through the smokebox door. Work has gone well, but the elements had to be hand fitted as despite being made to the original drawing, as had our tubeplate, they did not line up.

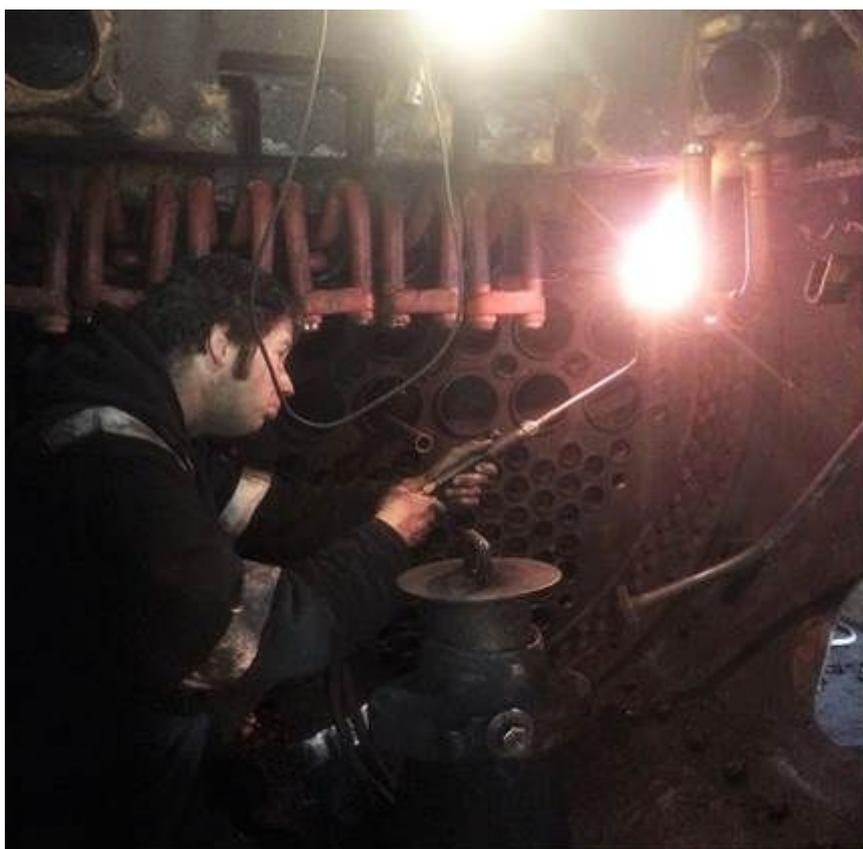
Chris heats up elements ready for bending to fit. Photo courtesy of Dave Fowler.

The fitting and boxing up of the boiler was completed on Friday 8th April. The next day a successful steam test was carried out and the loco was out on the first Whitby service in the morning. Our thanks must go to the shed staff at Grosmont for carrying out these repairs so quickly and efficiently allowing the loco to go back into service with the minimum of delay.
