B1 NEWS *flash*

Newsflash of the Thompson B1 Locomotive Trust

August 2015

Wheelset repairs continue.....

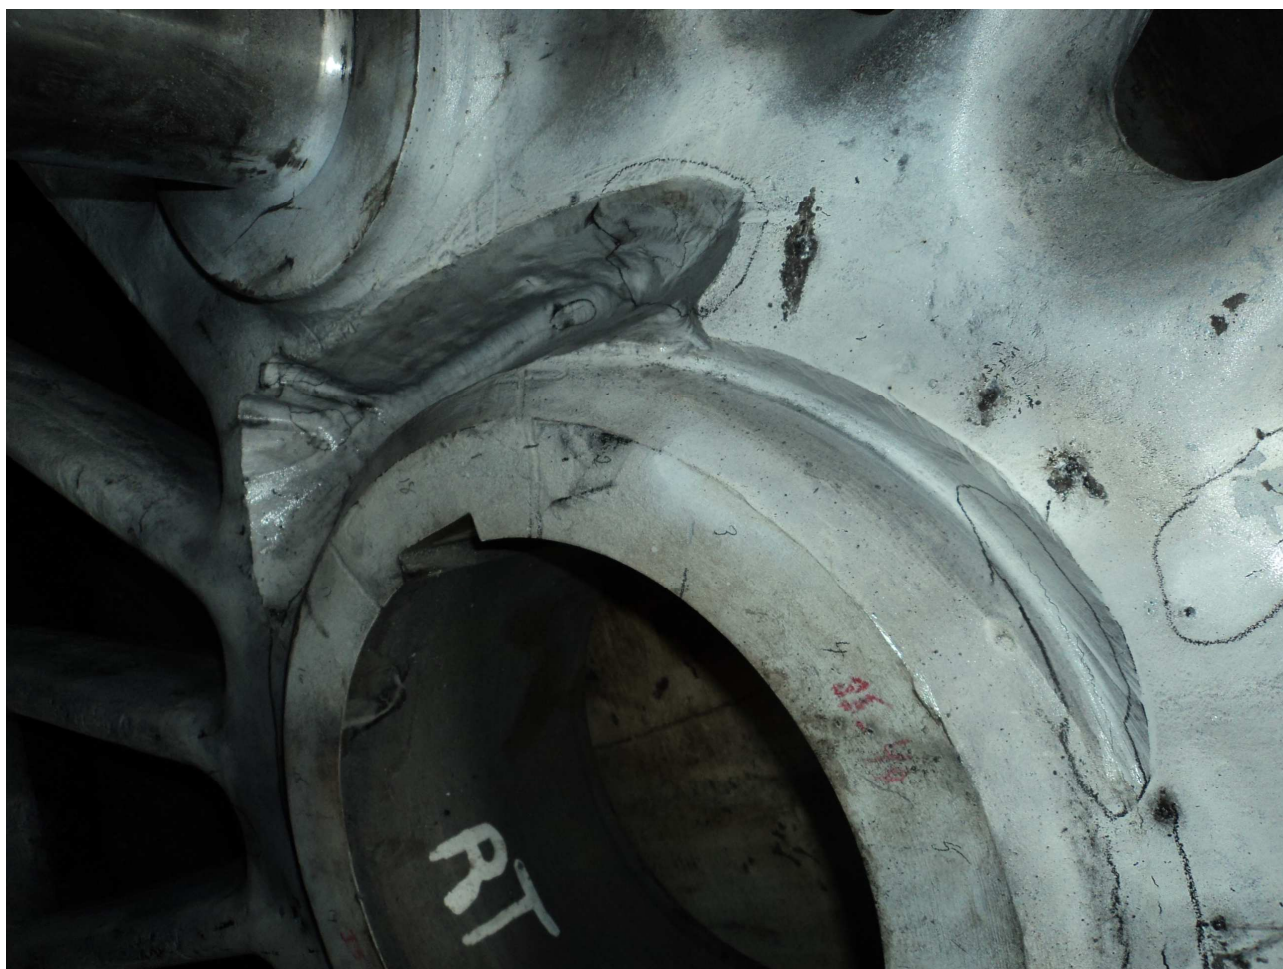
Showing just how much has had to be ground out to repair some of the cracks, this view is one of the rear wheels. Photo courtesy of Dave Fowler.

The cracks on the trailing wheels had been excavated to 70-80mm in one place on the hub. Although this appears deep, RSA were confident that the cracks had now been sufficiently ground out. A revised welding procedure was agreed so that welding could commence. As previously mentioned this process has to be done very carefully to avoid any distortion or cracking to the wheel and as it was taking longer than expected a start was made on the repairs to the leading and middle wheelsets. At the beginning of August the middle wheelset had been completed, however it does need a working party to clean it up and repaint the wheels. The leading wheelset was partially finished with half the cracks around the spokes completed. The work looks neat and hopefully the remaining cracks will be dealt with shortly.

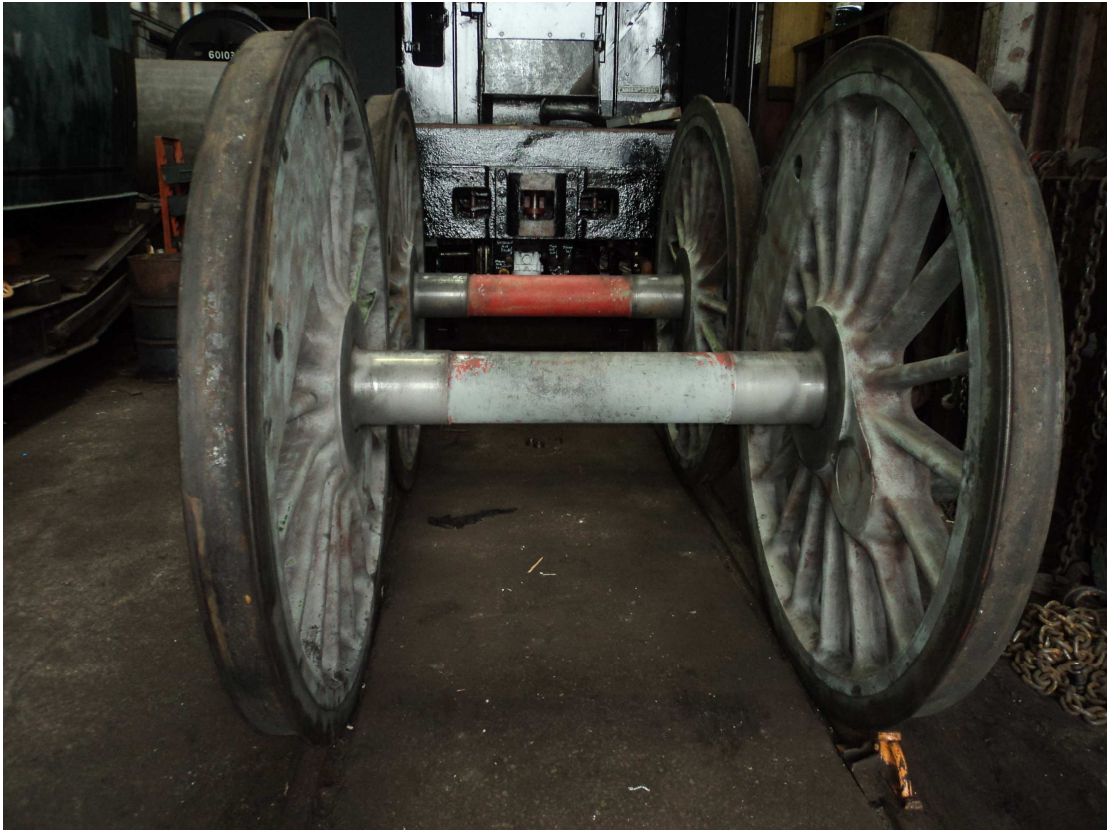
The lead and middle wheelsets sandblasted and ready for inspection.

By mid July all the wheelsets had been prepared ready for RSA Labs to carry out a magnetic particle examination to assess whether the welding of the cracks could commence. The good news was that RSA inspected the front two newly-prepared wheelsets and only a couple of cracks were identified. After some discussion it was decided to leave these alone at least until the trailing wheelset is finished.

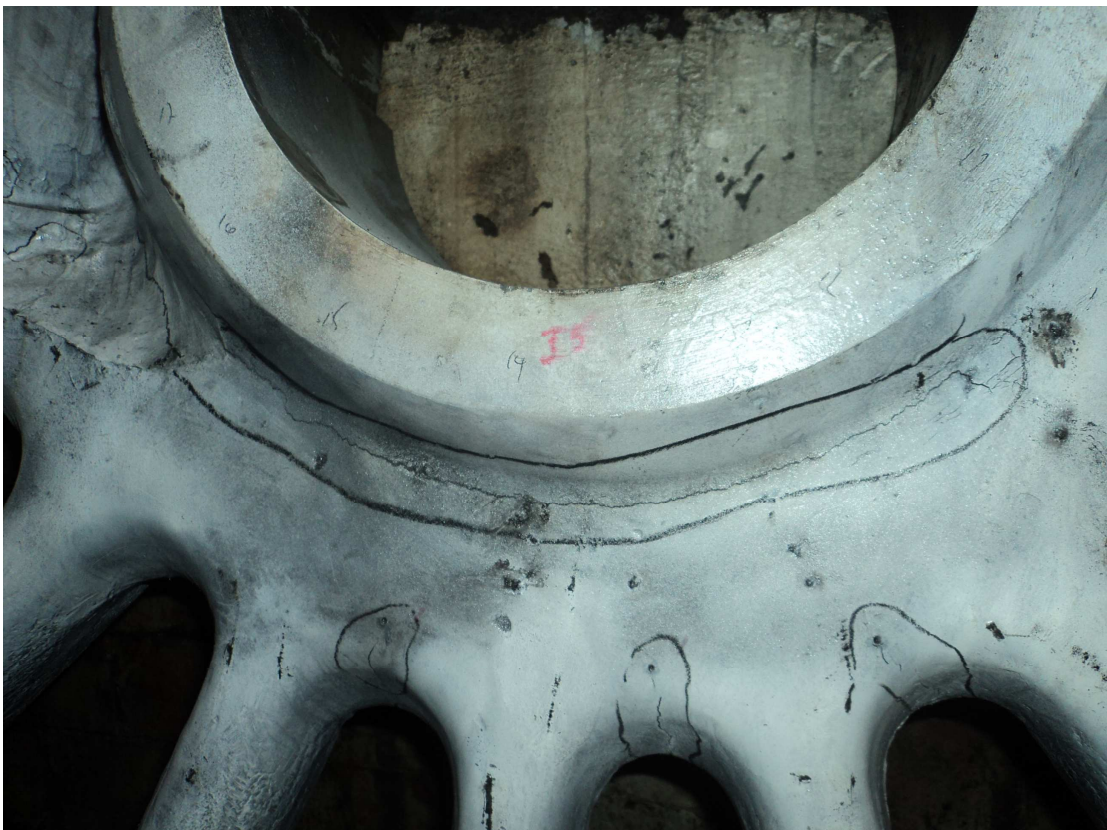
A radial crack on the right trailing wheel, 15mm deep and going all the way round the hub.

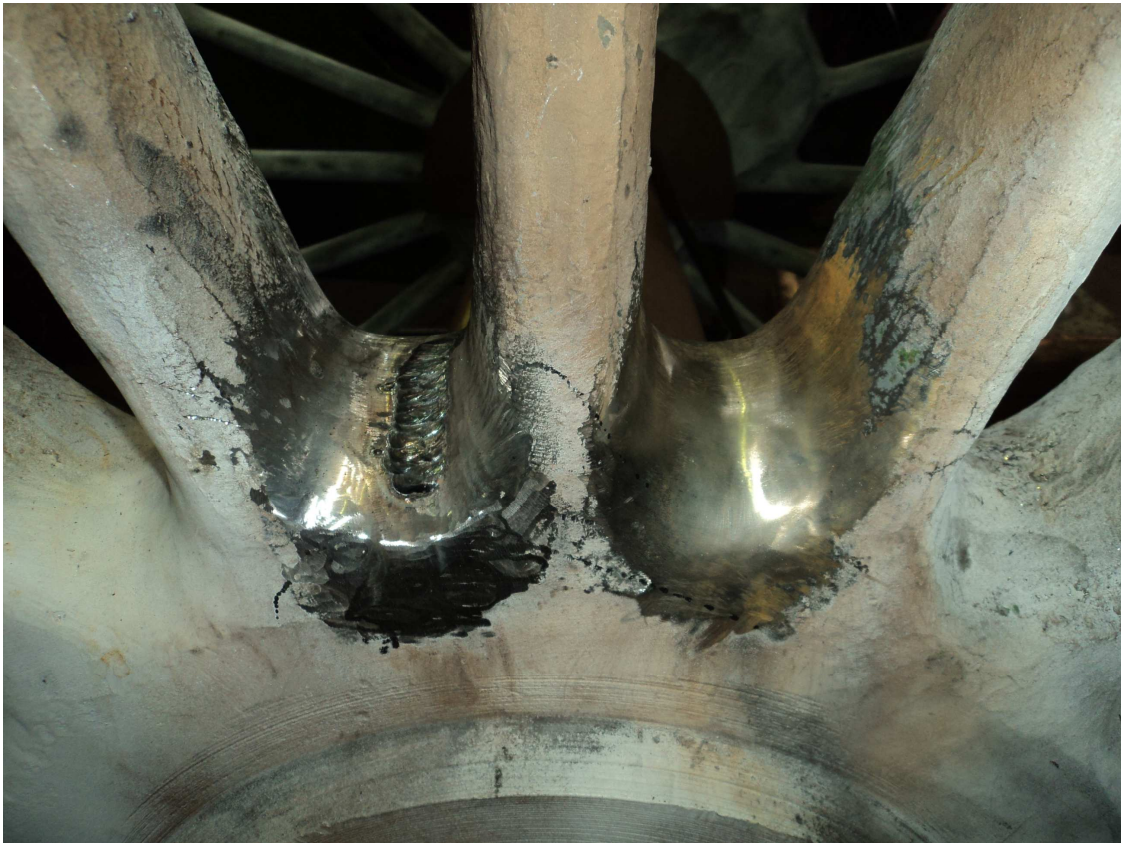
Here work is in progress on the leading wheelset with welding partially complete

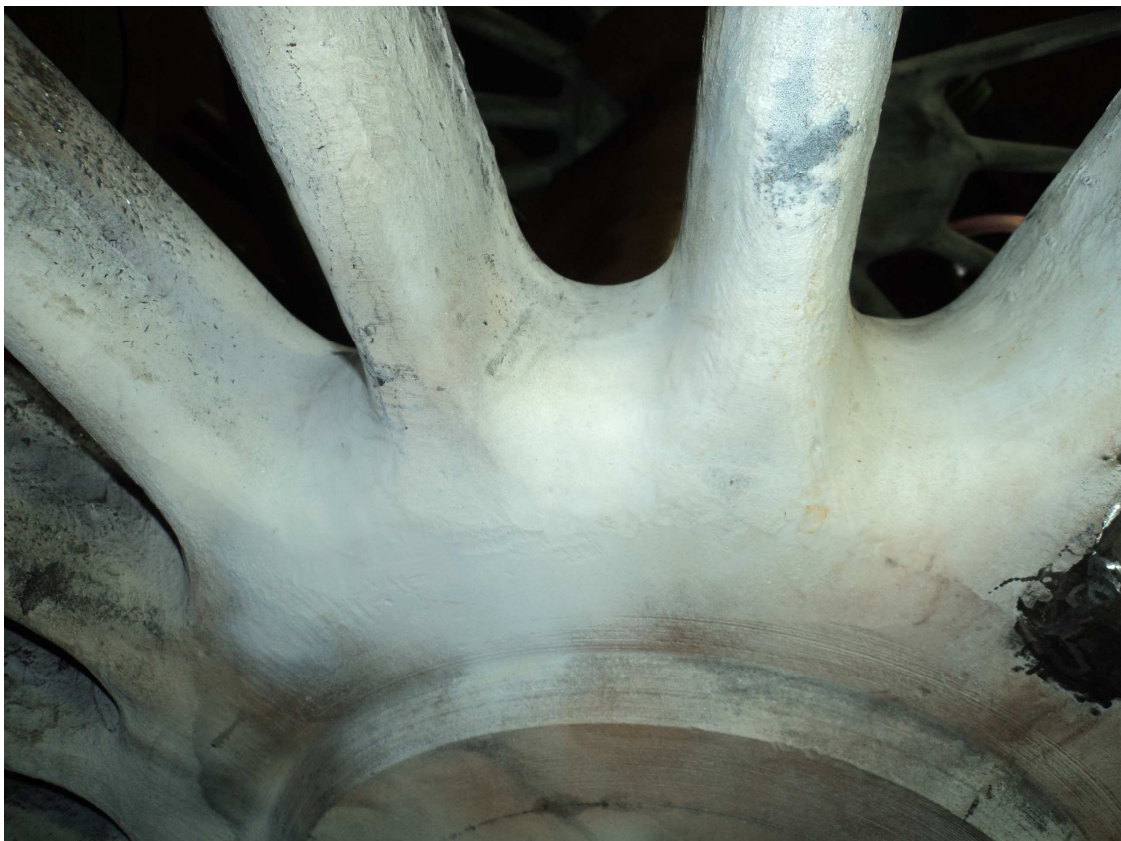
Half the cracks around the spoke and hub have been completed and this shows the neat finish that has been achieved. All photos courtesy of Dave Fowler.
